NASA/TM—1999-209388

# Inspection of Space Station Cold Plate Using Visual and Automated Holographic Techniques

Arthur J. Decker, Matthew E. Melis, and Kenneth E. Weiland
Glenn Research Center, Cleveland, Ohio

August 1999

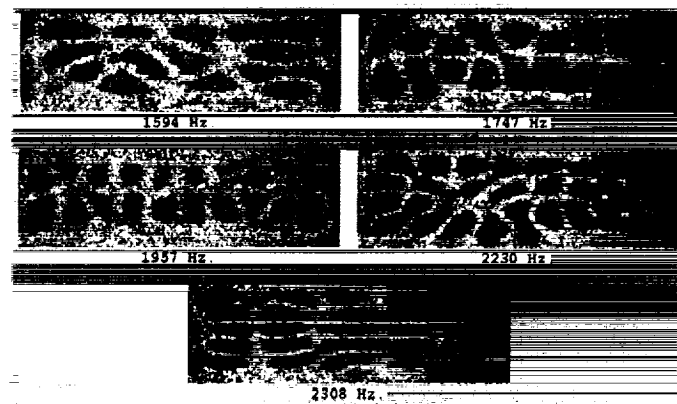
Figure 6.—Characteristic patterns before pressurization and relaxation.

Figure 6 shows five characteristic patterns before execution of the pressurization and relaxation cycles. Figure 7 shows the same characteristic patterns after 2000 cycles.

For the whole-plate inspections, the neural net was trained to flag changes in the pattern shown at 1957 Hz in Fig. 6. The pattern at zero amplitude shown in Fig. 4 in large pixel format and the patterns at 2230 Hz and 2308 Hz in Fig. 6 were used as examples of other modes. That is, the neural net was trained to respond exactly the same to these modes, and the visualization software was programmed to color the characteristic patterns of these modes yellow. The visualization software was programmed to color the characteristic pattern at 1957 Hz green, if the threshold condition was met. 67 X 20 large pixels cover the whole-plate for the neural networks as in Fig. 4. Each pattern is

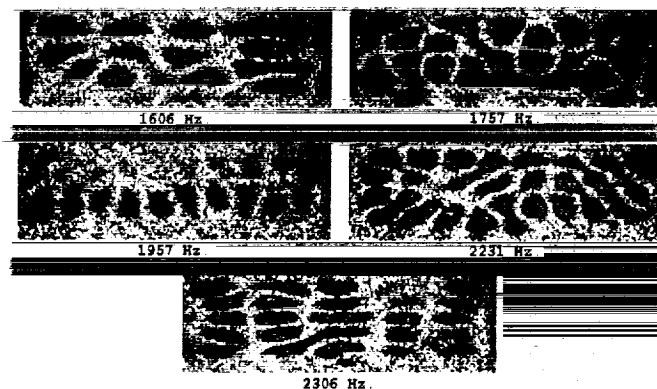
Figure 7.—Characteristic patterns after 2000 pressurization cycles.

The results are believed to show no significant changes after 2000 and 3000 pressurization and relaxation cycles. But the optical patterns certainly are not completely free of change. There are contrast changes between Figs. 6 and 7, in particular for the mode at 1957 Hz. That mode was selected for inspection by the neural network.

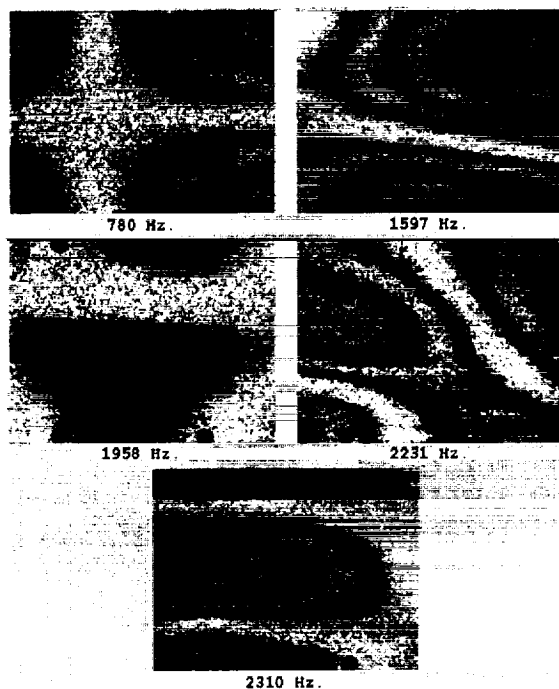
Figure 8.—Characteristic patterns for zoomed region between holes.

Figure 8 shows five characteristic patterns of the zoomed region considered to be most suspicious by the requesters of the test. Figure 9 shows the same five characteristic patterns after 1000 pressurization and relaxation cycles. Through-holes can be seen in these figures.

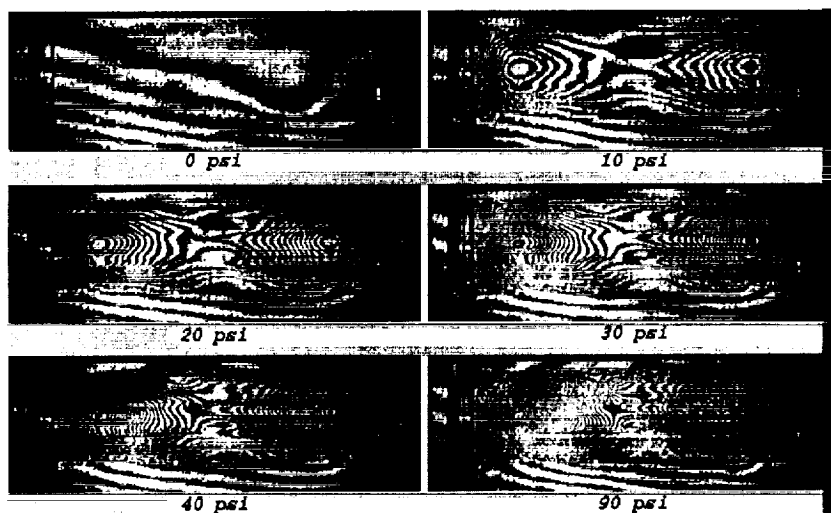
Figure 11.—Response of neural-net in zoomed region.

Figure 11 shows relaxed and pressurized states for the zoomed region.

The net flagged the mode for the pressurized state as being different from the mode for the relaxed state in Figs. 10 and 11. This result is not surprising and should not be interpreted as meaning that a change in structural integrity occurs at pressurization. Neural nets were discovered to be sensitive to mode-shape changes caused by small changes in bolt torque.

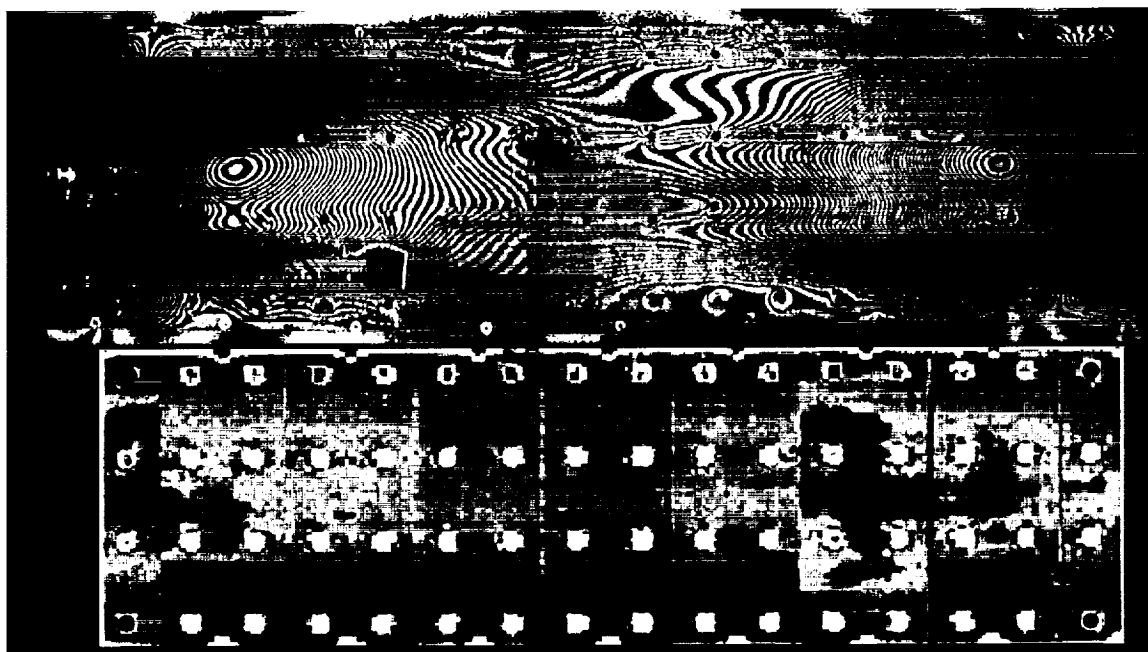
Figure 12 shows the fringe patterns from real-time holograms recorded at several values of pressure, and Fig. 13 shows a comparison between the ultrasonic C-scan and double-exposure holography.

The results from real-time holography in Fig. 12 and double-exposure holography in Fig. 13 show a rather non-uniform response to pressurization. But Fig. 14, recorded from double-exposure holograms, did not show changes after 3000 pressurization and relaxation cycles.
